Accident Investigation Report

FIRE SHELTER DEPLOYMENT
I-90 COMPLEX, LOLO NATIONAL FOREST
NORTHERN ROCKIES
MISSOULA, MONTANA

August 10, 2005

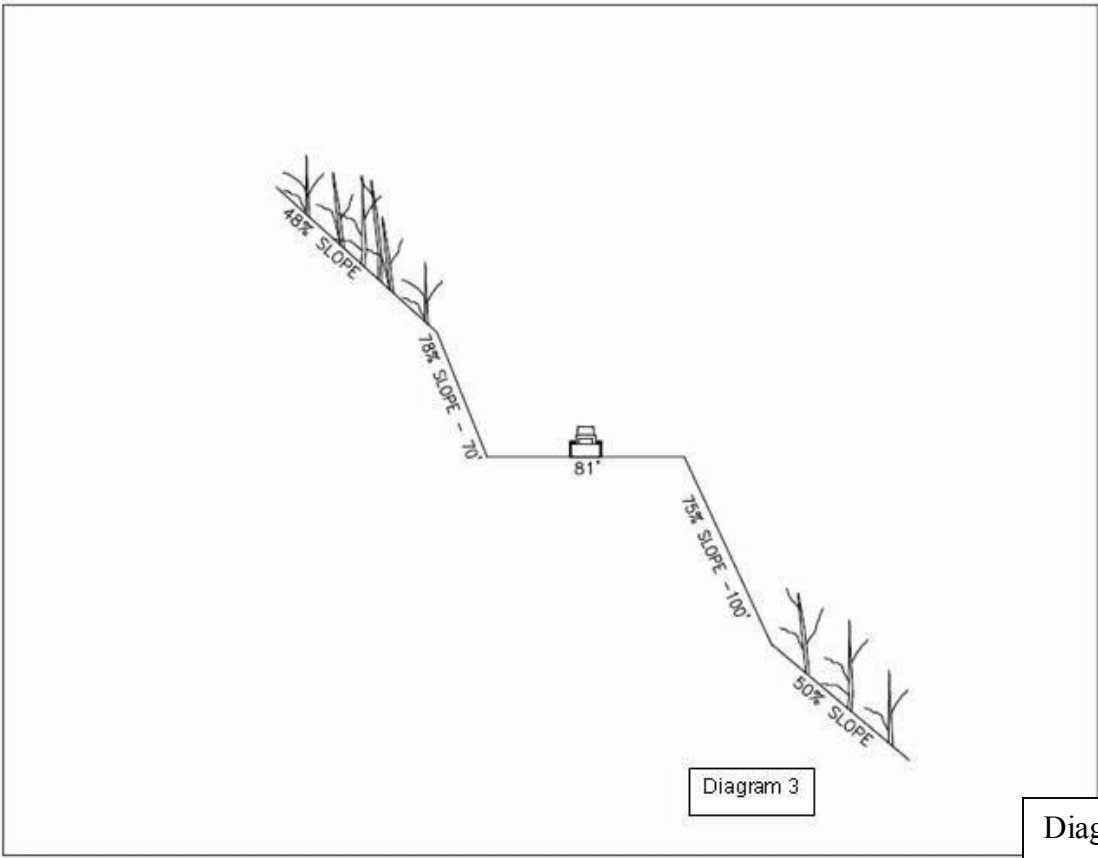
Discussion: Areas on both sides of the safety zone all burned as a crown fire. The deployment area appears to have provided considerable protection from the intense fire behavior. The combination of the protection offered by the deployment site, the dozer and the fire shelters allowed the firefighters to remain unharmed (See Diagram 2 and 3).

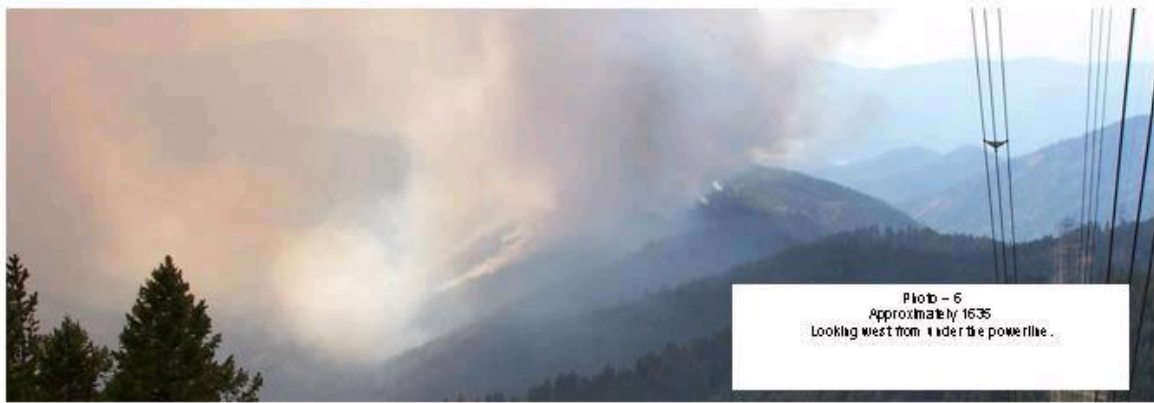
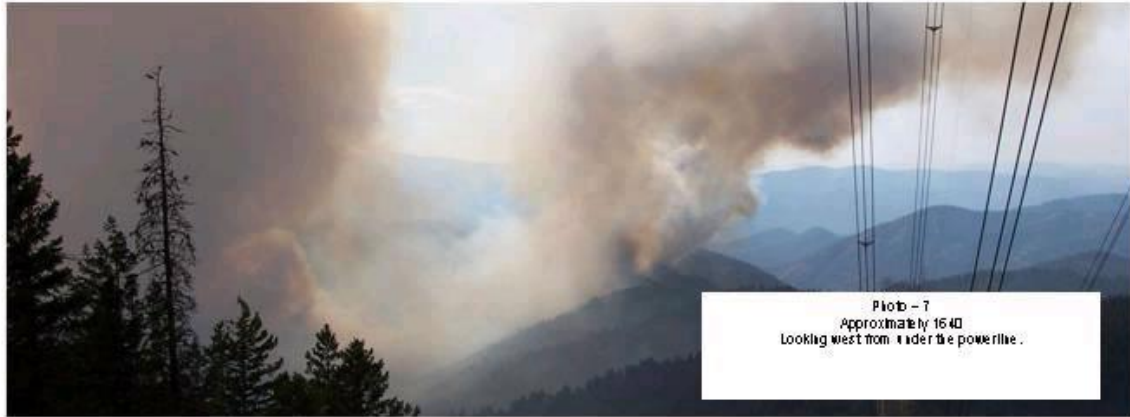
Photo #6 and Photo #7

By 1730 discussions at the Operations Section Chief/ Branch level consider establishing an anchor at the heel of the slopover and going to work, but they determine conditions are too dangerous. The slopover across the drainage has a full head of steam, proceeding east, along the ridge (Photos 6 and 7).

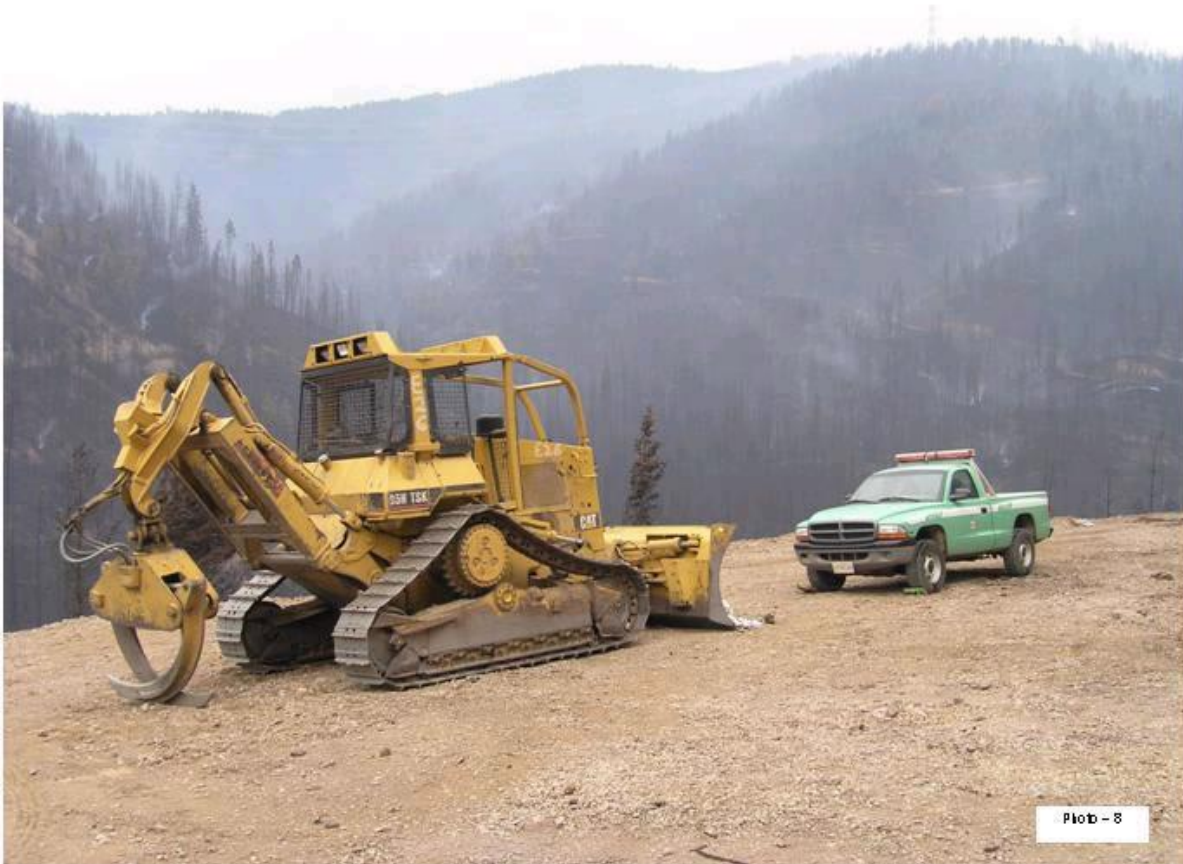
Photo #8

The dozer is placed in the middle of the safety zone and the pickup is placed up canyon from there.

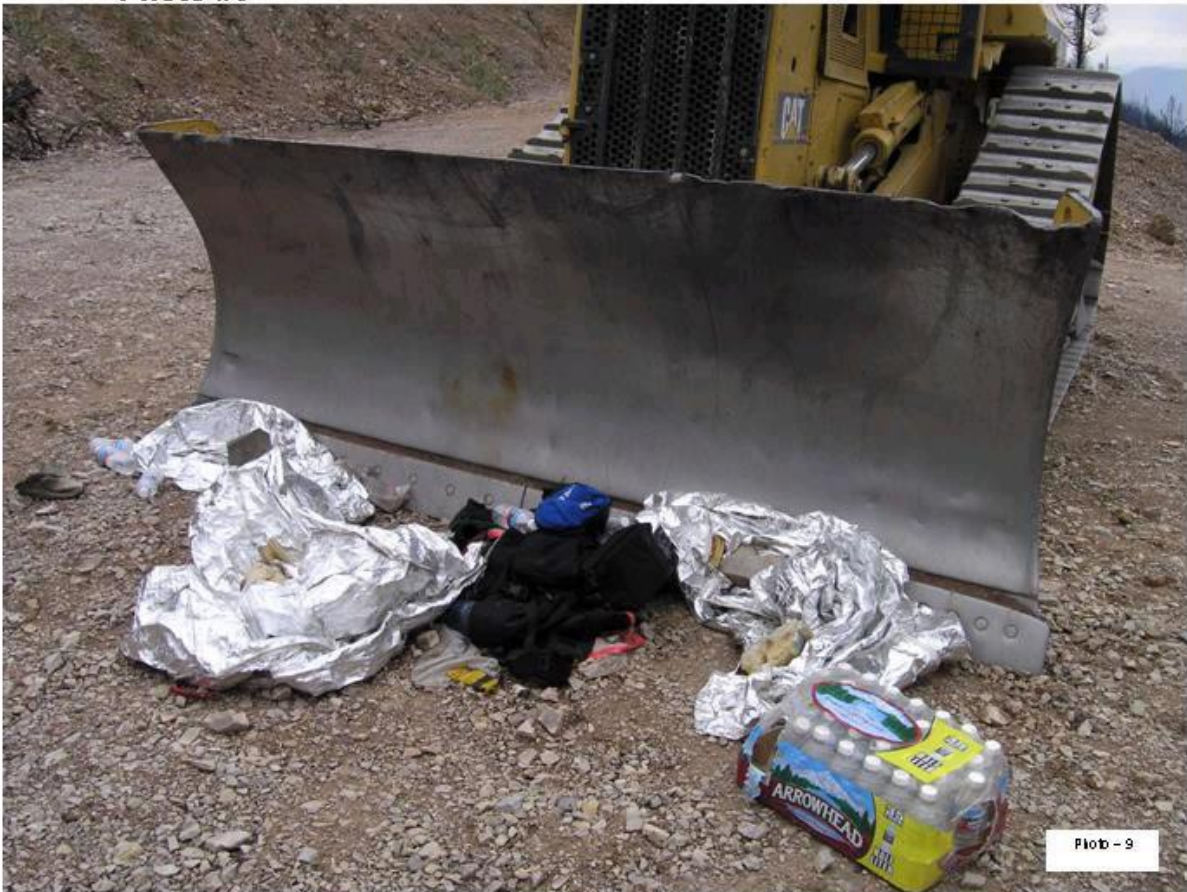
Photo #9

Line gear and a case of drinking water are staged forward of the blade.

The shelters show no heat damage, nor do the dozer or pickup truck. The shrink-wrapped plastic on the staged drinking water next to them shows no heat damage, nor the worn plastic wrap on the dozer seat, approximately six feet off the ground. The light bar on the truck, also over 6 feet above the ground, does not show any damage. An empty water bottle in the bed of the pickup shows melting, but appears to have been melted when an ember ignited a ball cap in the bed. Moving away from the center of the alternate safety zone, east down the 19 Road, indicators of more heat become apparent, with melted bottles at 100 feet, and the flagging used to close the road, melts and blows onto the cut-bank. The nearby fusee does not ignite, but the packs burn completely. (See Photo 9 from previous.)

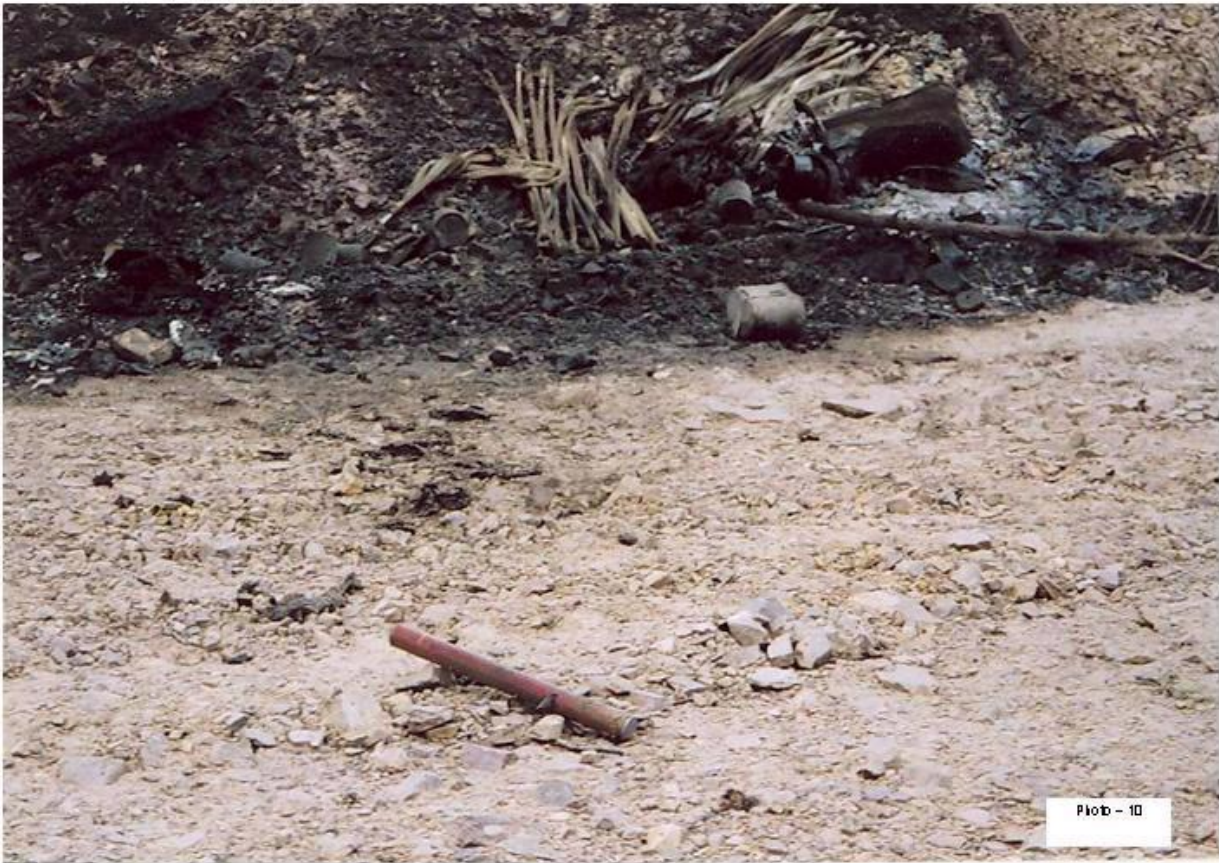
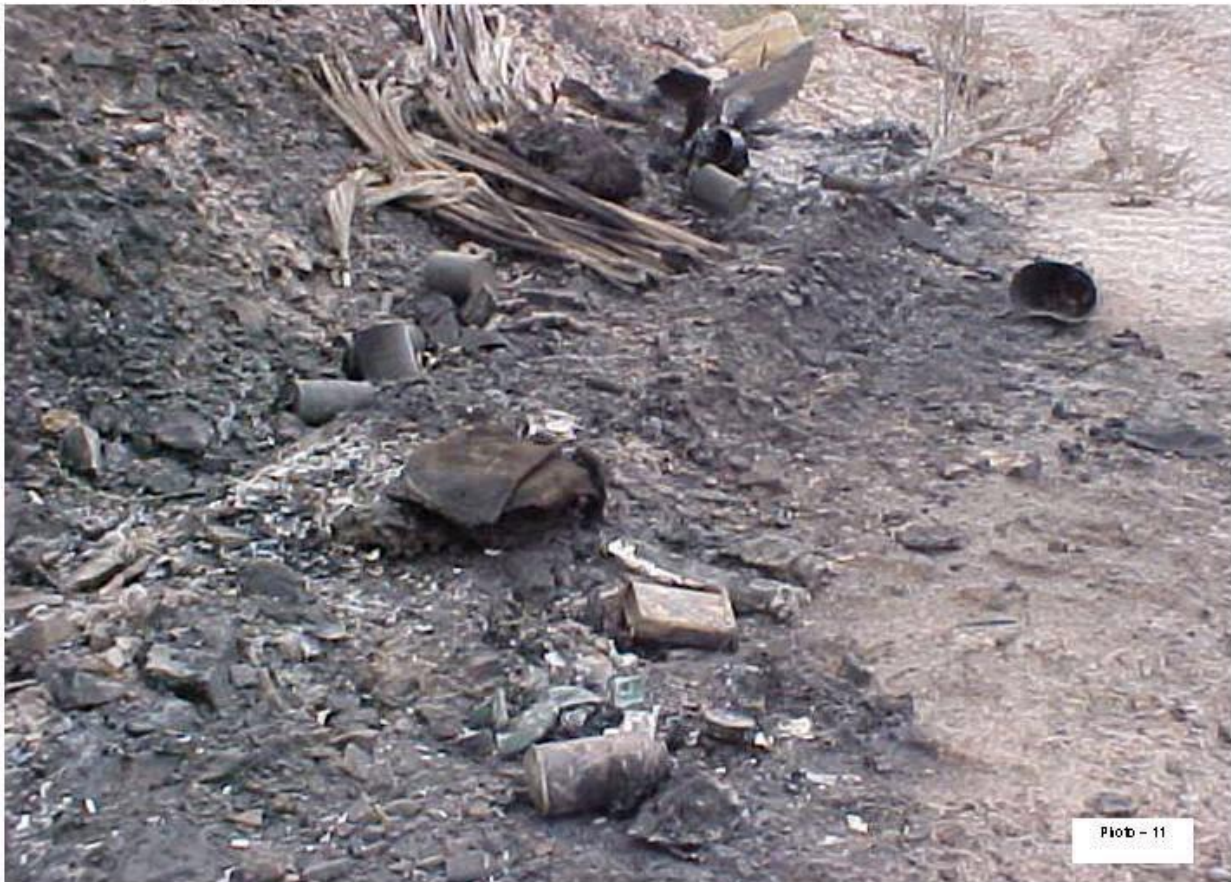
Fusees are dispersed down the road to the east.

They have removed their packs and other flammables from the pickup bed and placed them along the cut bank, down-wind, to eliminate flammables in the bed of the pickup (remnants of packs – Photo 11).

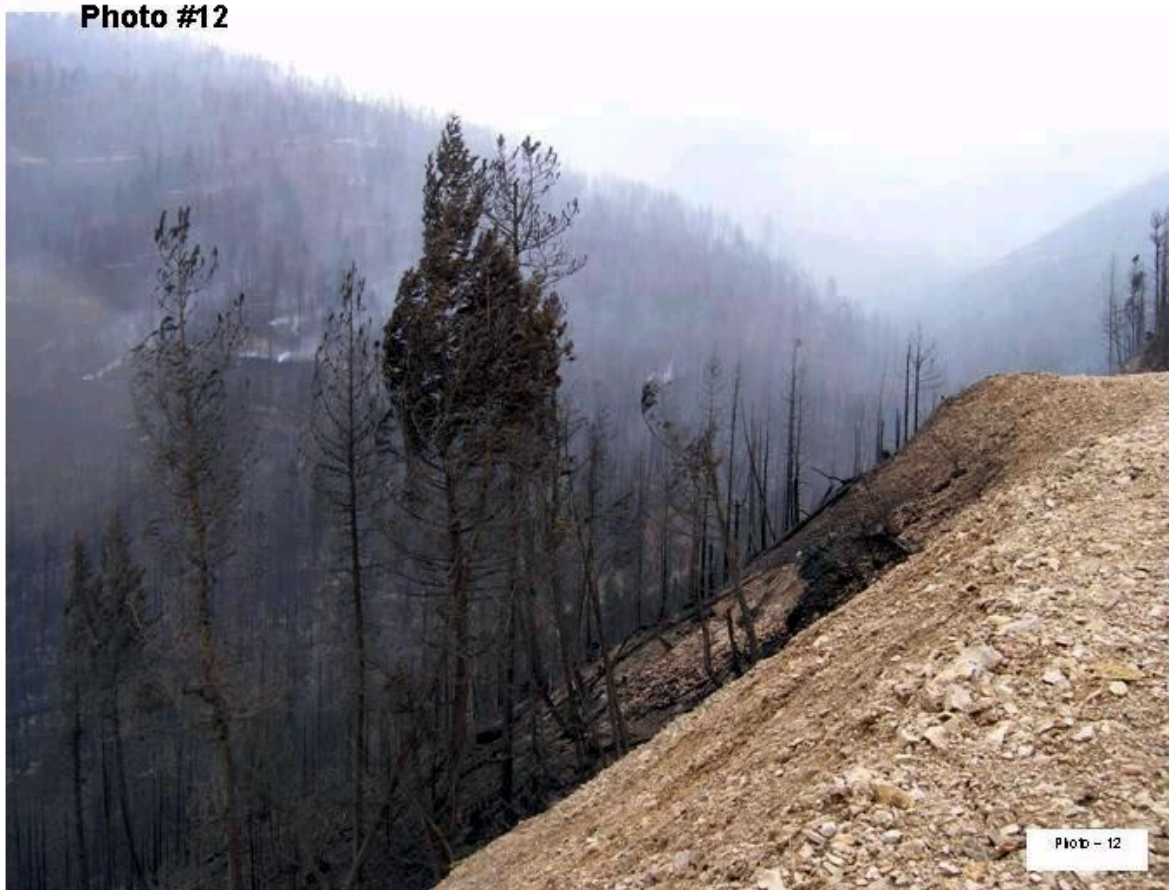
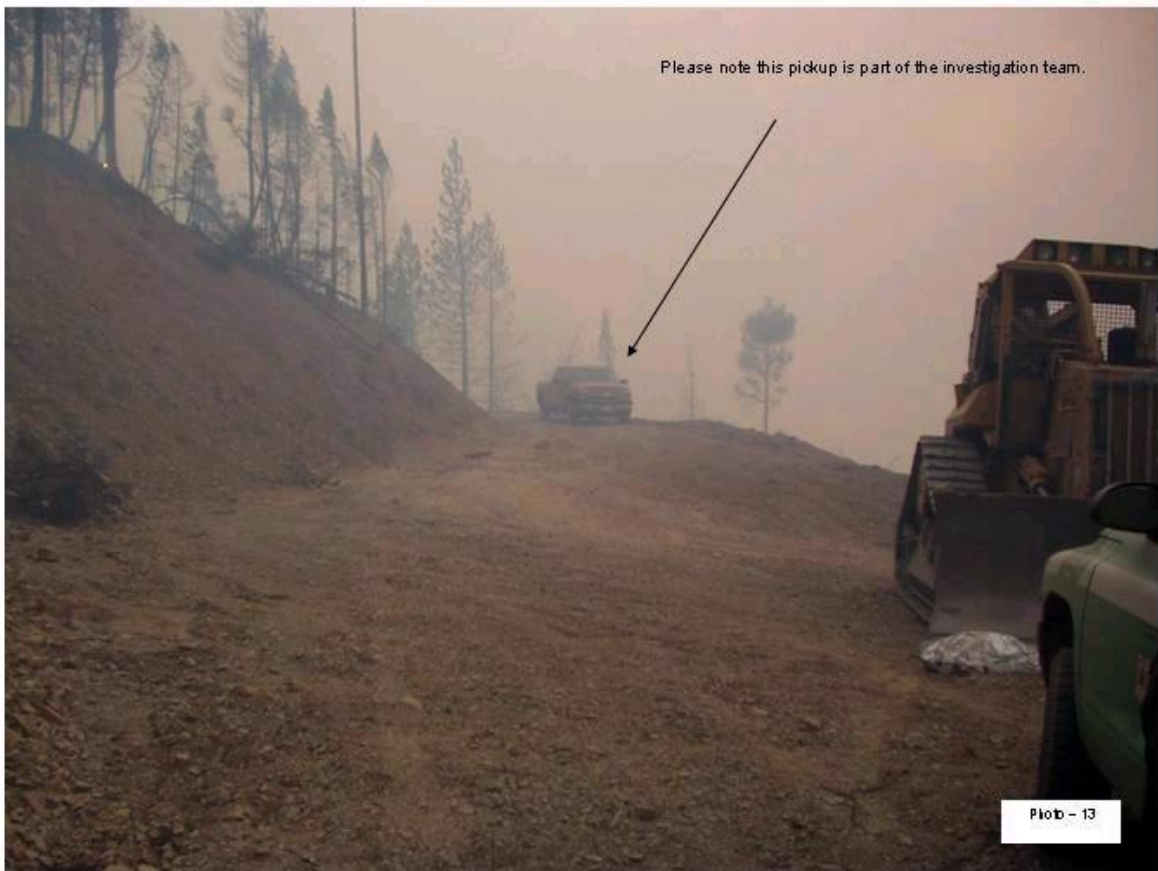
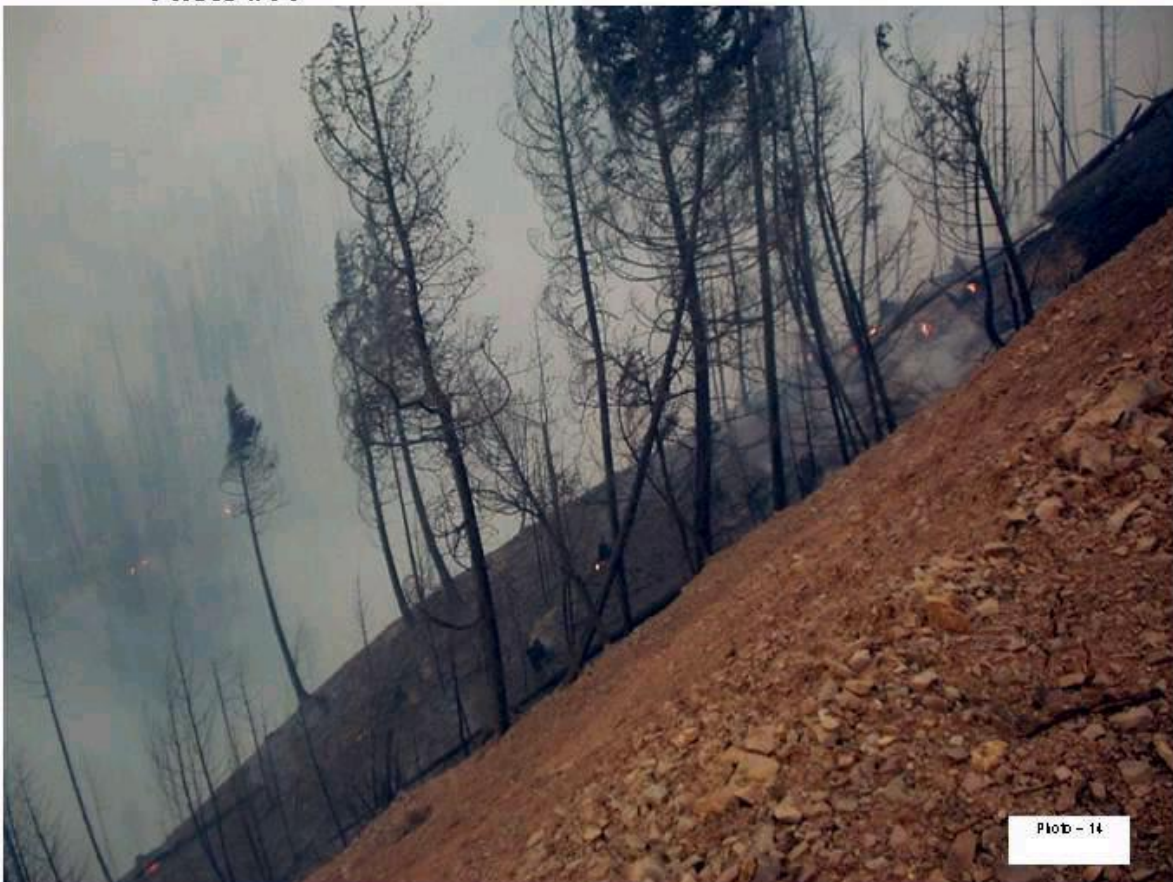
These 3 photos show the vegetation frozen in the direction of hot gas flow.
