Accident Investigation Report

FIRE SHELTER DEPLOYMENT
I-90 COMPLEX, LOLO NATIONAL FOREST
NORTHERN ROCKIES
MISSOULA, MONTANA

August 10, 2005

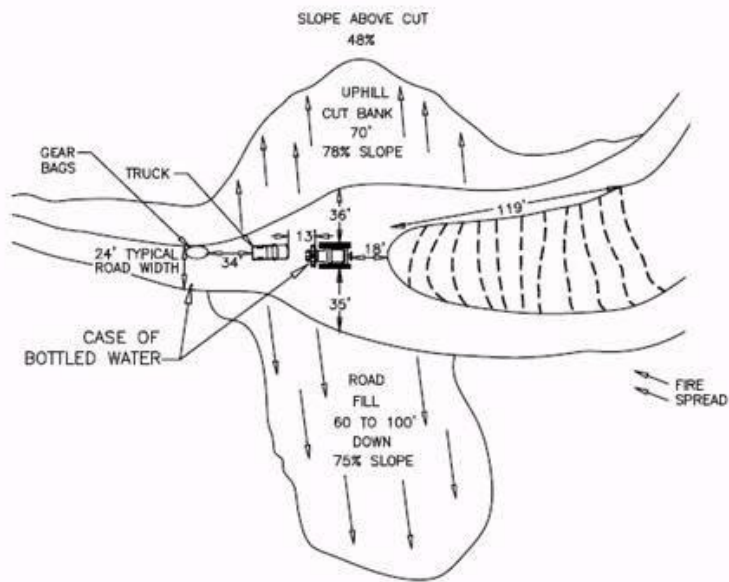
Discussion: Areas on both sides of the safety zone all burned as a crown fire. The deployment area appears to have provided considerable protection from the intense fire behavior. The combination of the protection offered by the deployment site, the dozer and the fire shelters allowed the firefighters to remain unharmed (See Diagram 2 and 3).

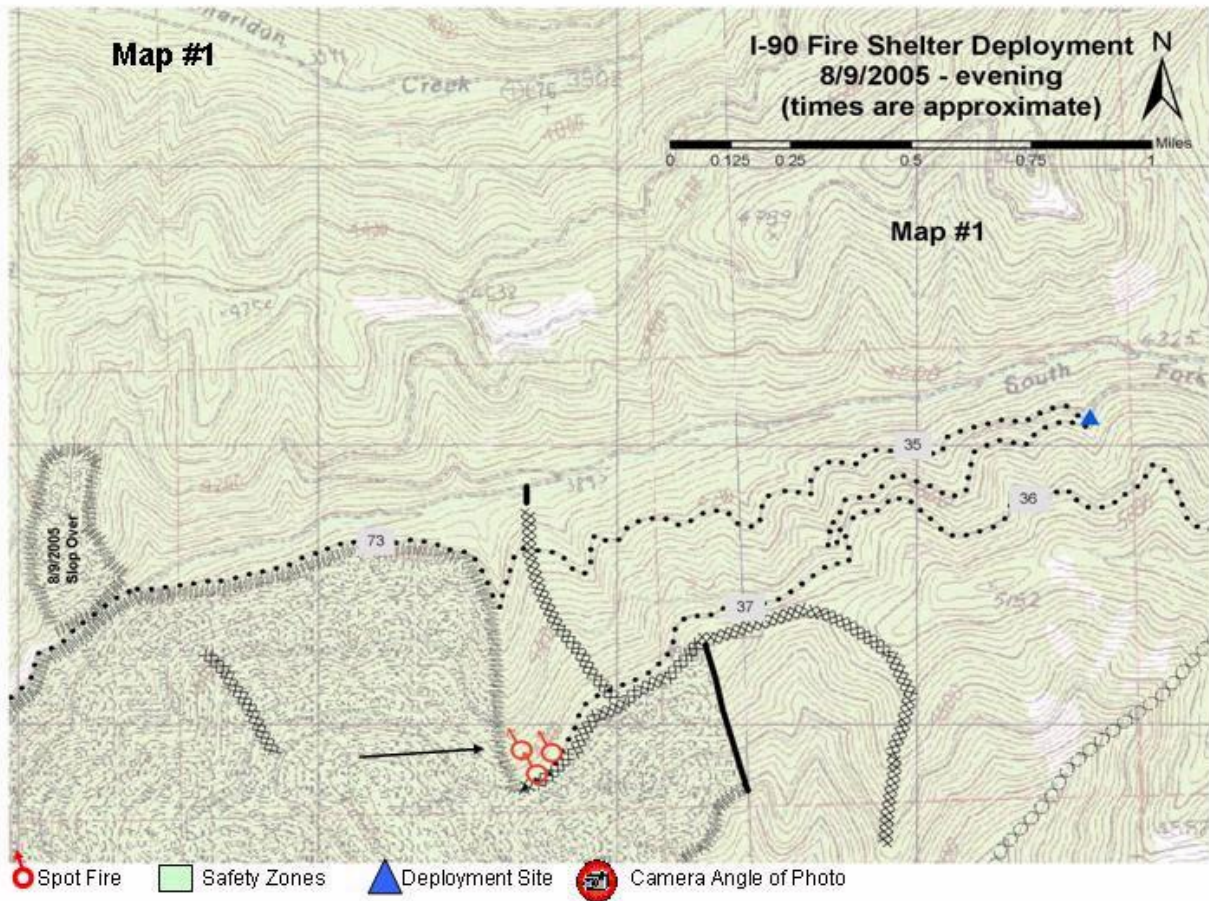
(Map 1)

This map shows the location of the fire and dozer fireline from the night before. Notice that the burnout from the adjacent division spotted over the ridge, and through the night blackened the south side of the saddle. This worked well for Interagency Hotshot Crew-A, who began the day with a meaningful safety zone (Upper Safety Zone) with black on both sides of the ridge.

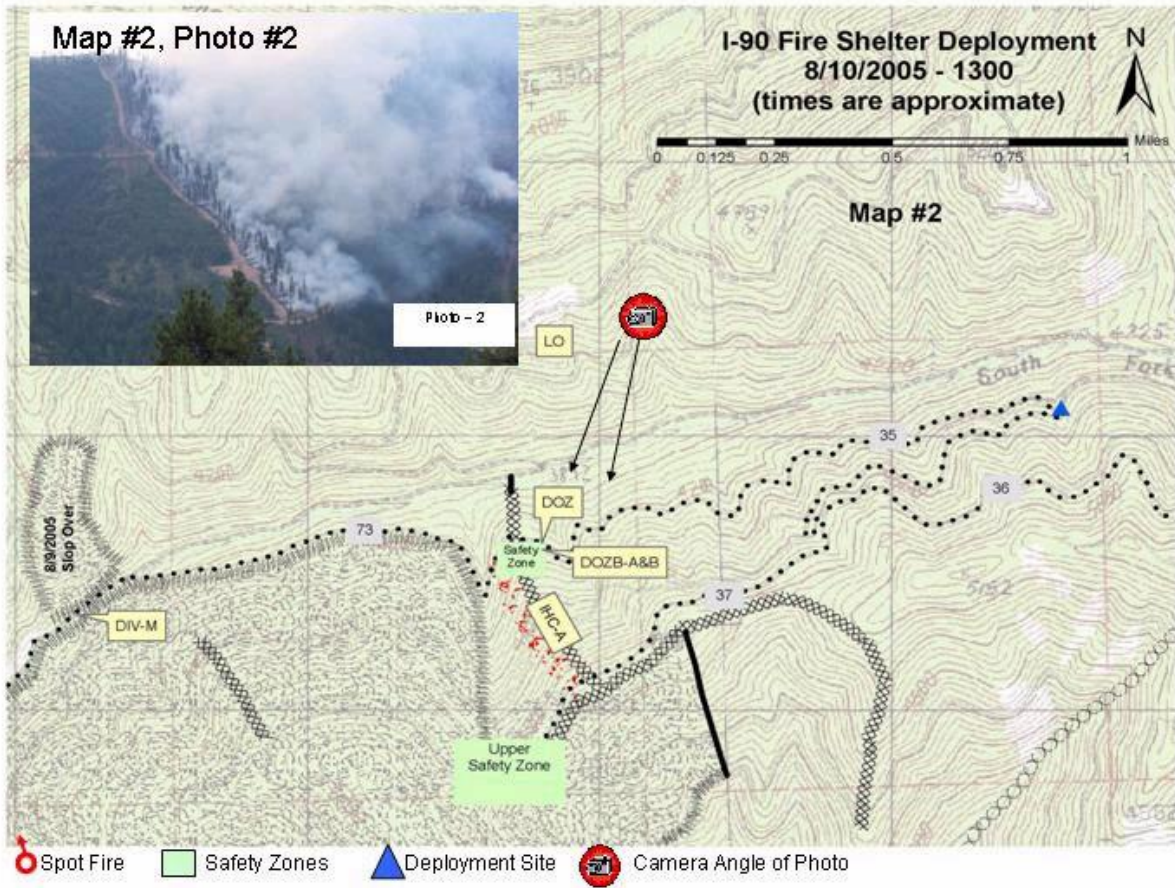
(Map 2 – Photo 2)

Interagency Hotshot Crew-A also posted a lookout directly across the canyon. With this anchor and lookout, Interagency Hotshot Crew-A burned out from the top down. The Dozer widened this line, heading south, towards South Fork of Nemote Creek, creating a safety zone just above the 35/73 Road. A handline completes the line into the riparian area. Everything below the 35 / 73 Road is considered a contingency line, as they intended to hold the fire above the road, and west of the dozer line. Map 2 also shows the dozer line at 1300 as the Interagency Hotshot Crew-A completes burnout operations.

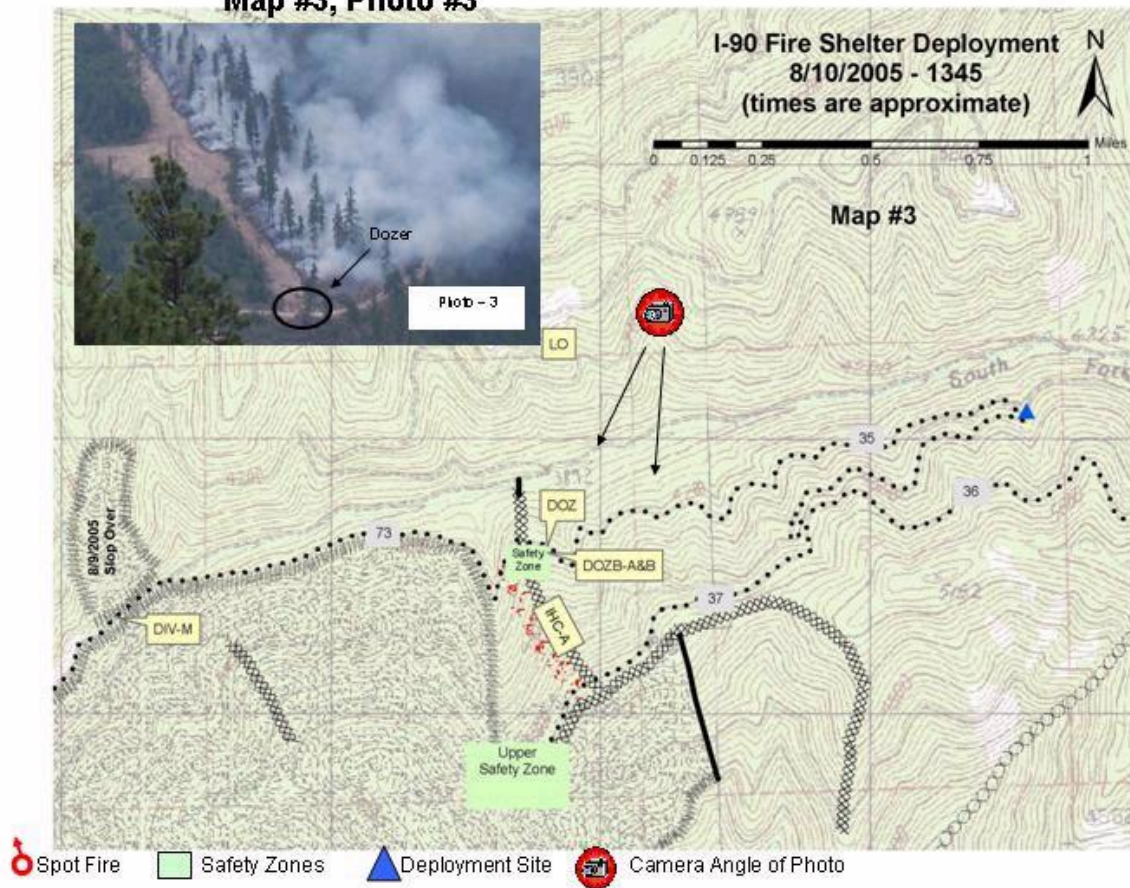
Map #3, Photo #3

The magnified photo inset shows the dozer at the bottom of this line on the 35 / 73 Road. At this time the Dozer Bosses are nearby eating lunch, and looking out for spots, rollouts, and watching the slopover downstream on the opposite side of the canyon.

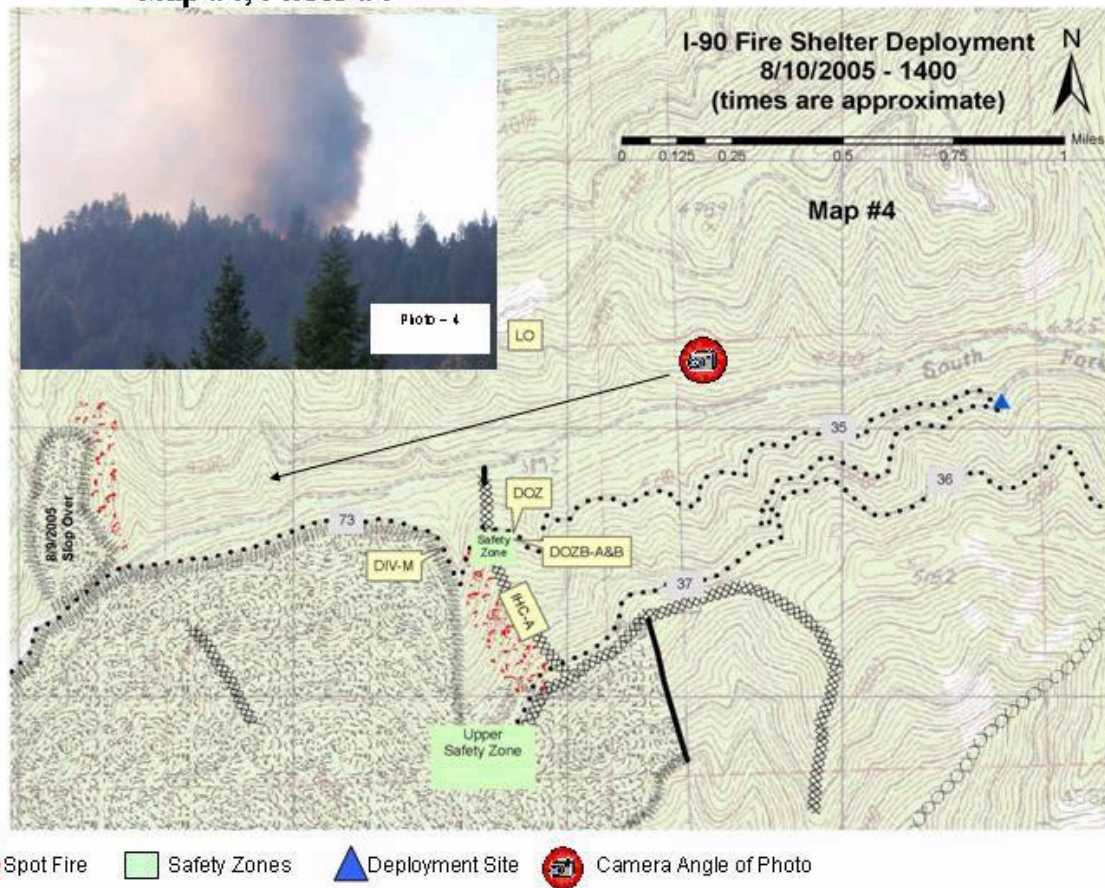
Map #4, Photo #4

First reports of the inversion lifting are at 1200, and fire behavior incrementally increases for the rest of the afternoon, just as it had on previous days. At 1400, they notice the slopover across the canyon becoming more active.

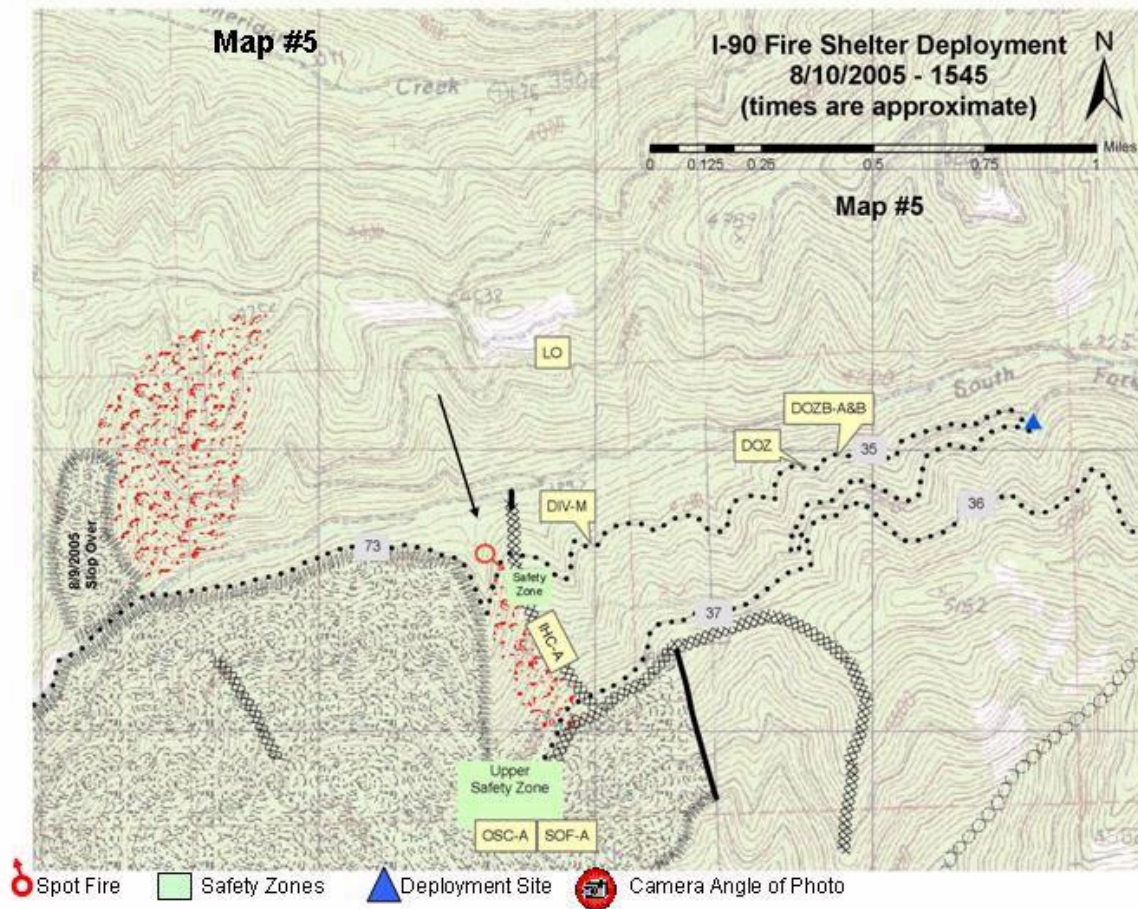
(Map 5)

By 1545 the slopover has a well-developed plume and is now established on the far ridge, moving east along the ridge. The Dozer and Dozer Bosses have moved up canyon one mile to where the slopover can be observed, assisting as a lookout for Interagency Hotshot Crew-A.

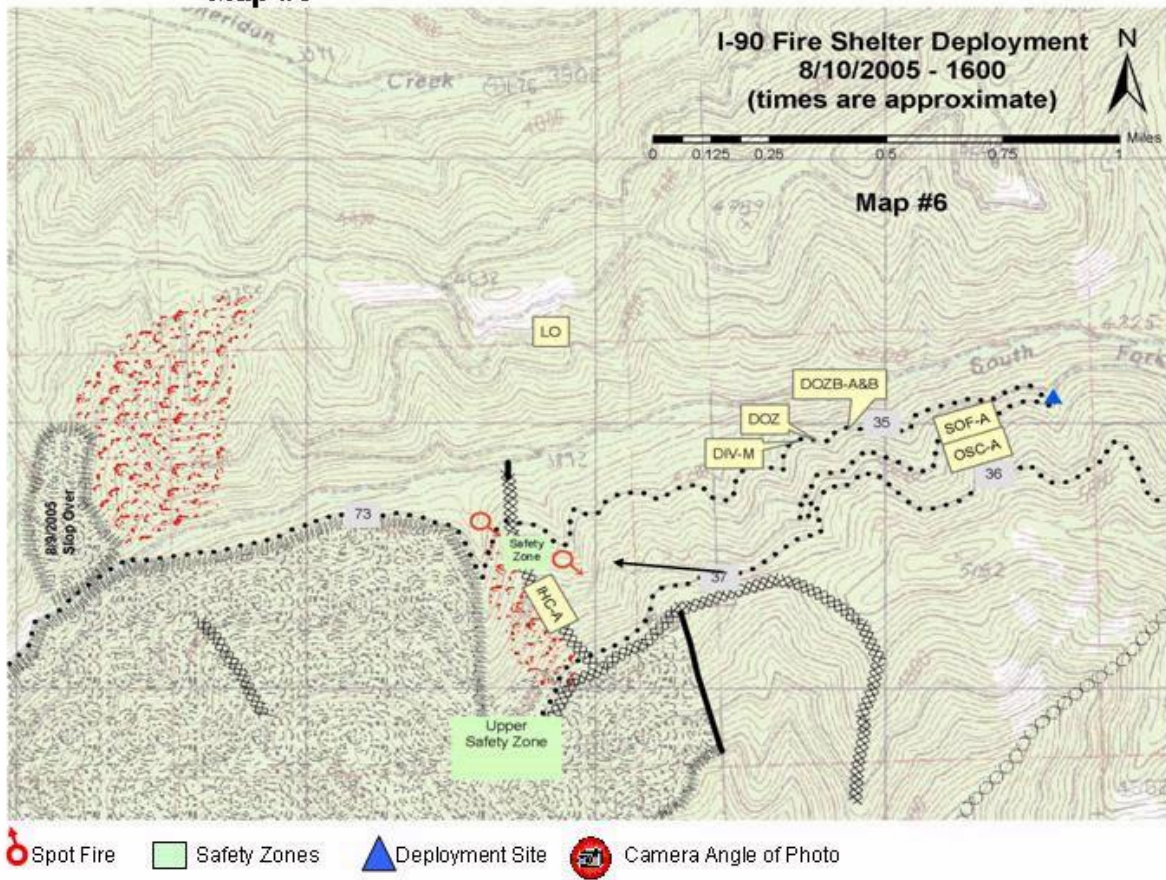
Map #6

At 1600 another small spot appears above the road, outside the dozer line. With close proximity to the Lower Safety Zone, Interagency Hotshot Crew-A Supervisor dispatches two crewmembers to put it out. Operations Section Chief-A arrives back with the Dozer and Dozer Bosses, as well as Division-M. After short consultation, as Safety Officer-A arrives; Division-M orders resources to safety zones. Division-M orders resources assigned to the slopover to Drop Point-22, and orders Task Force Leader-A to take charge of those resources.

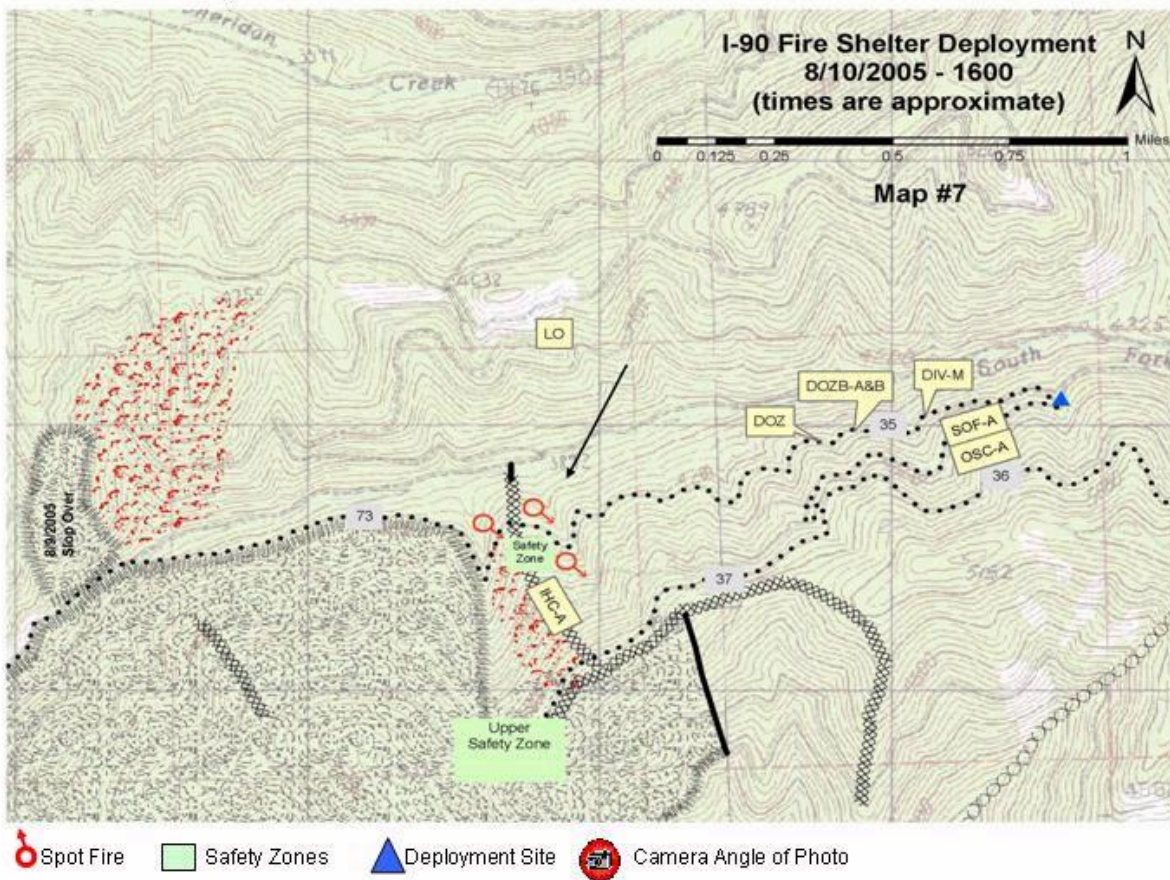
Map #7

Dozer Boss-A diverts a loaded helicopter with bucket to drop its load on a “new” spot below the road, outside the contingency line. He recognizes this spot as being ‘in our backdoor’ and a risk to their escape route. Ordered out again by Division-A, Dozer Boss-A says he would like to put one more load of water on the spot. He orders the helicopter to load and return.

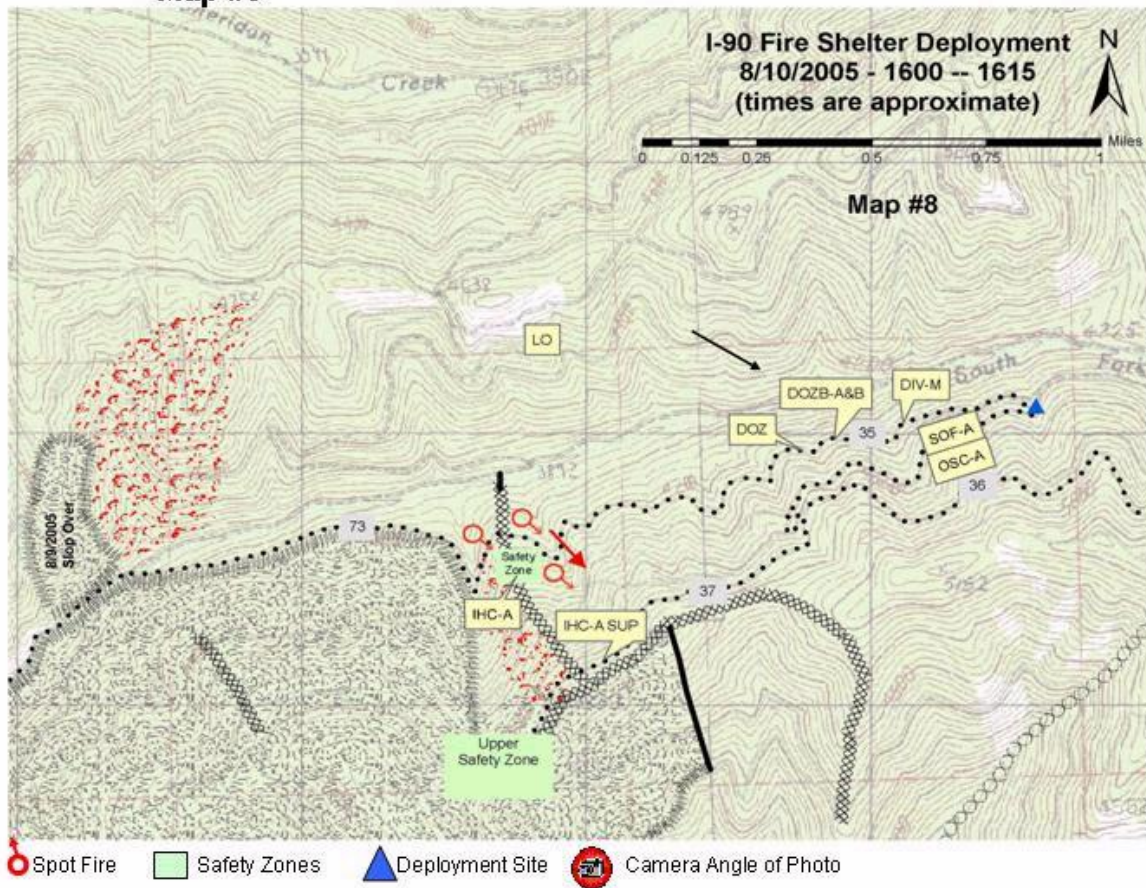
Map #8

However, the helicopter does not return, and the Dozer, Dozer Bosses-A and B soon head out towards the Upper Safety Zone, closely following Division-M.

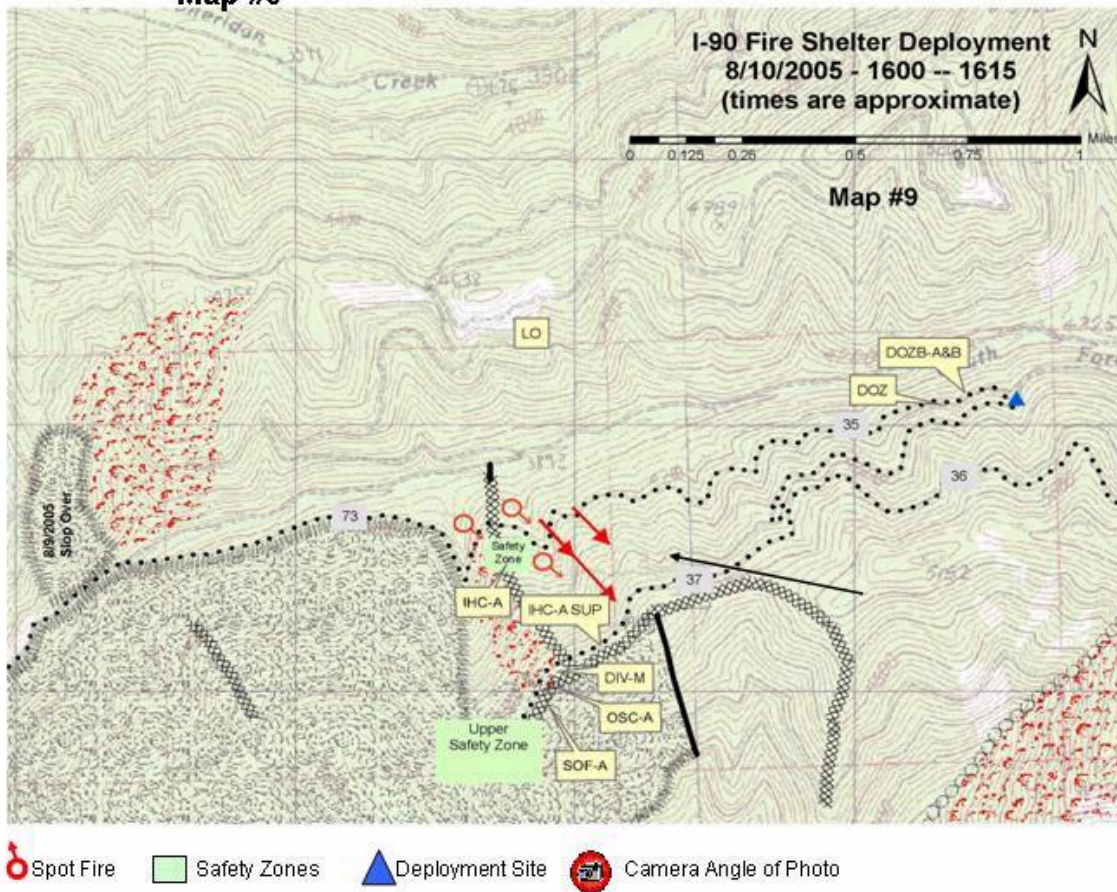
Map #9

At about 1615, as Operations Section Chief-A, Safety Officer-A and Division-M are driving towards the Upper Safety Zone, Interagency Hotshot Crew-A Supervisor, having moved his crew into the Lower Safety Zones has walked to the Upper Safety Zone and becomes a lookout from his position on the road at the top of the dozer line. He notices the spots are spreading fast, and additional spot fires have developed east of the dozer line and that the 37 Road leading to the Upper Safety Zone may become compromised. This is communicated to Division-M, Operations Section Chief-A, Safety Officer-A, and Dozer Bosses-A and B. Safety Officer-A, Operations Section Chief-A, and Division-M just make it to the Upper Safety Zone as the road behind them is cutoff by flames from the spot fires.

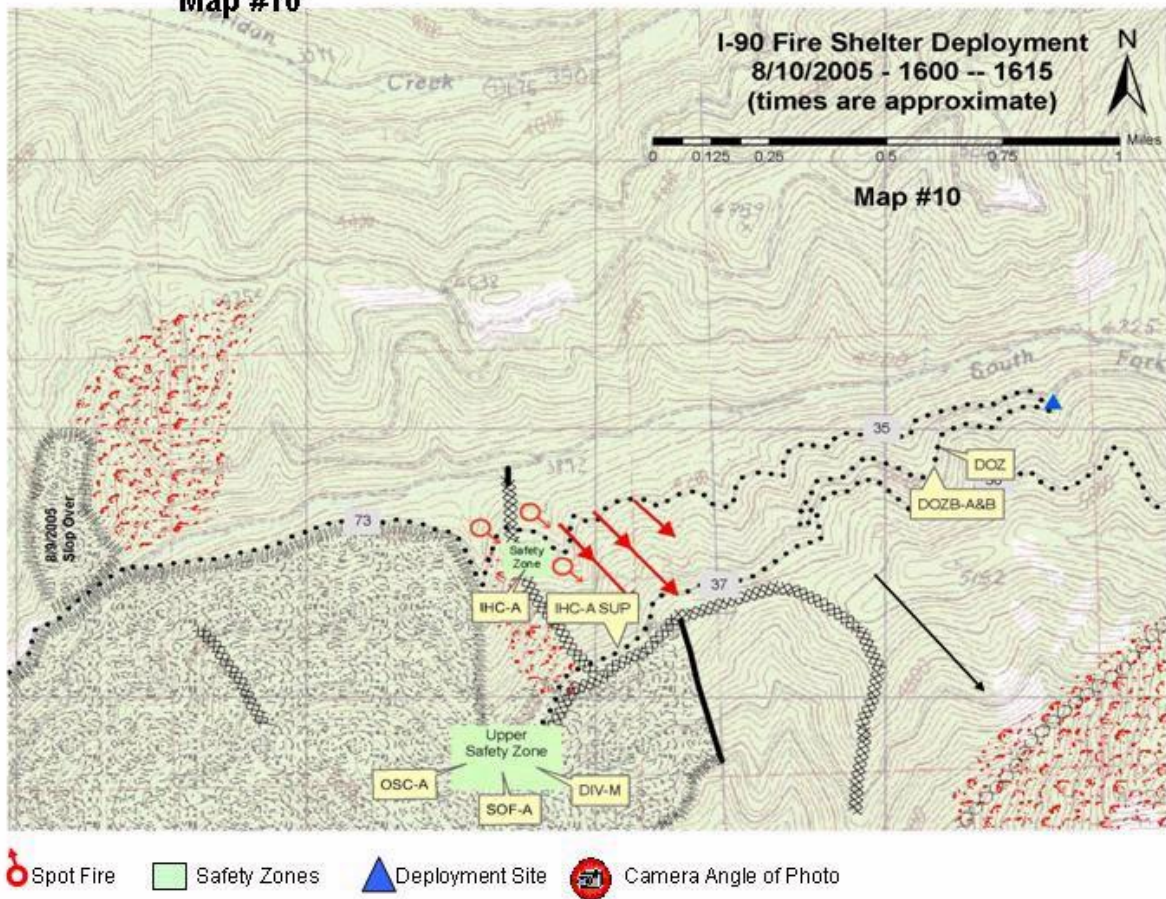
Map #10

A radio discussion between Division-M and Dozer Boss-A covers a couple of options; as 37 Road is not an option, perhaps 36 Road out towards Division-H would work, but a smoke column is appearing above the ridge from Division-H. Division-M suggests abandoning the dozer and taking the operator with them in the pick-up out the 36 Road, but does not know the situation in Division-H.

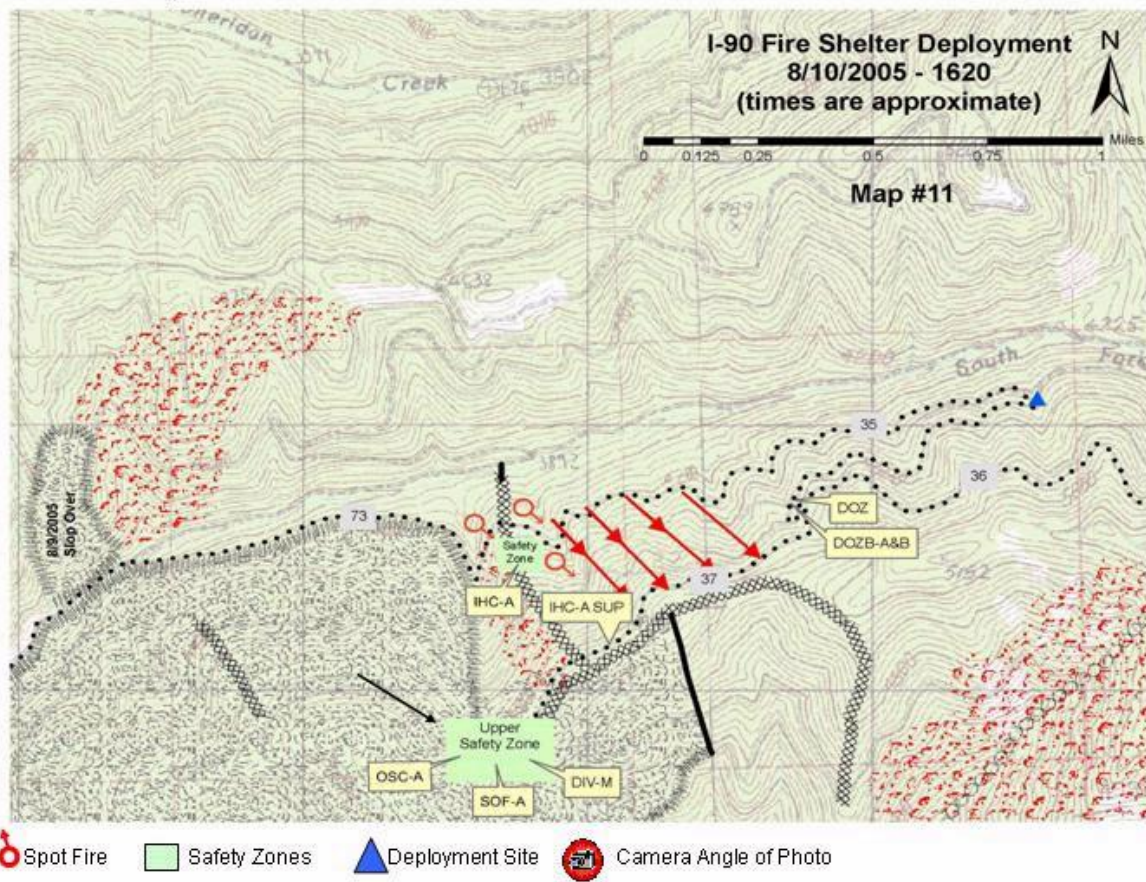
Map #11

Operations Section Chief-A is right there with Division-M, and checks with Operations Section Chief-B. Operations Section Chief-B has first hand knowledge regarding the 36 Road, but knows Division-H is also experiencing active fire, and cannot tell them if the 36 Road is open.

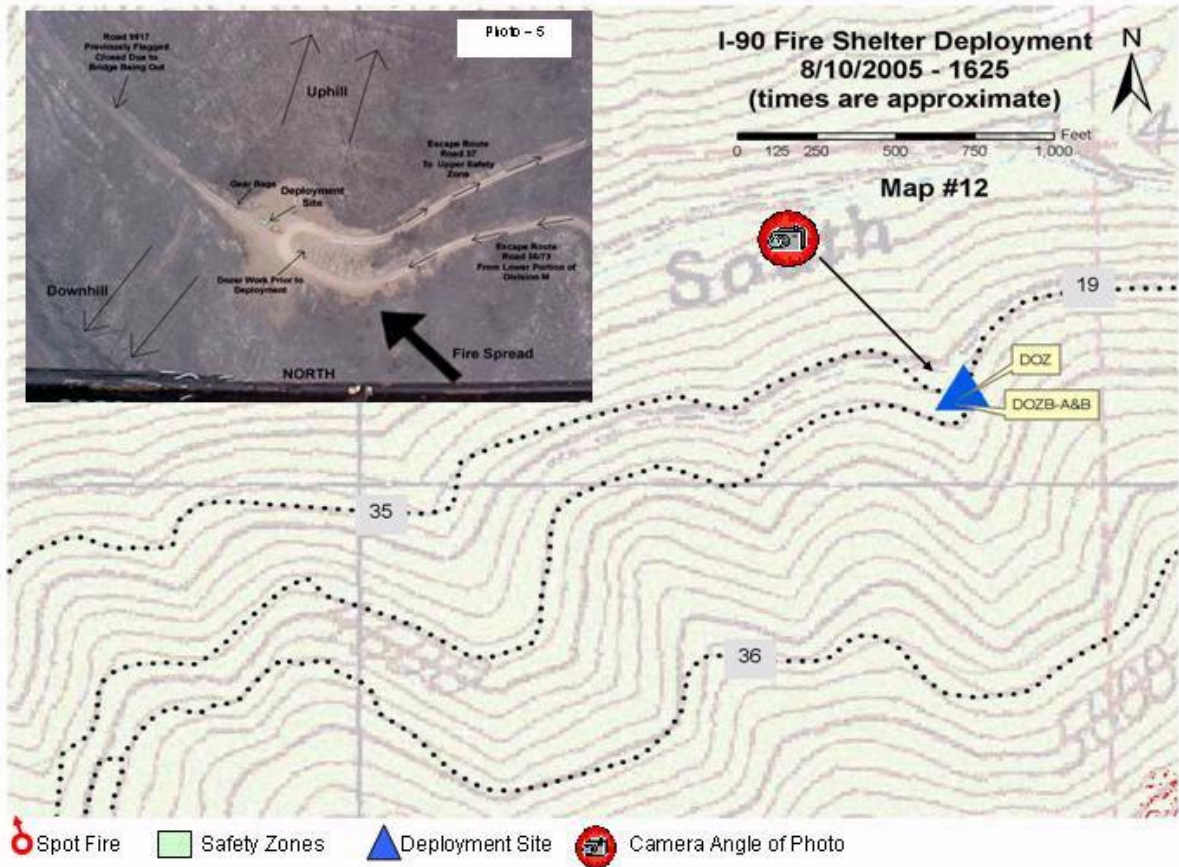
Map #12, Photo #5

Dozer Bosses-A and B take decisive action, choosing to move themselves and the dozer back to the switch back junction. As the 36 Road is an unknown, they choose a known entity with high probability for success over an unknown.

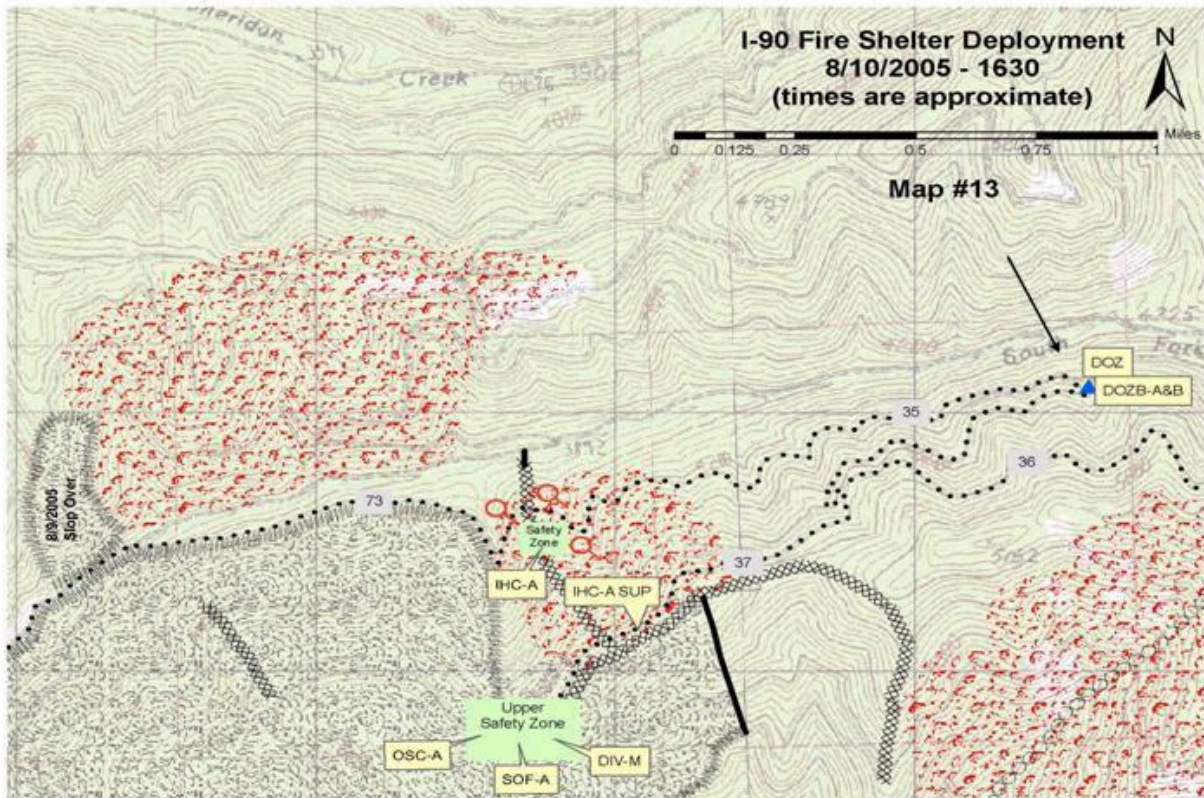
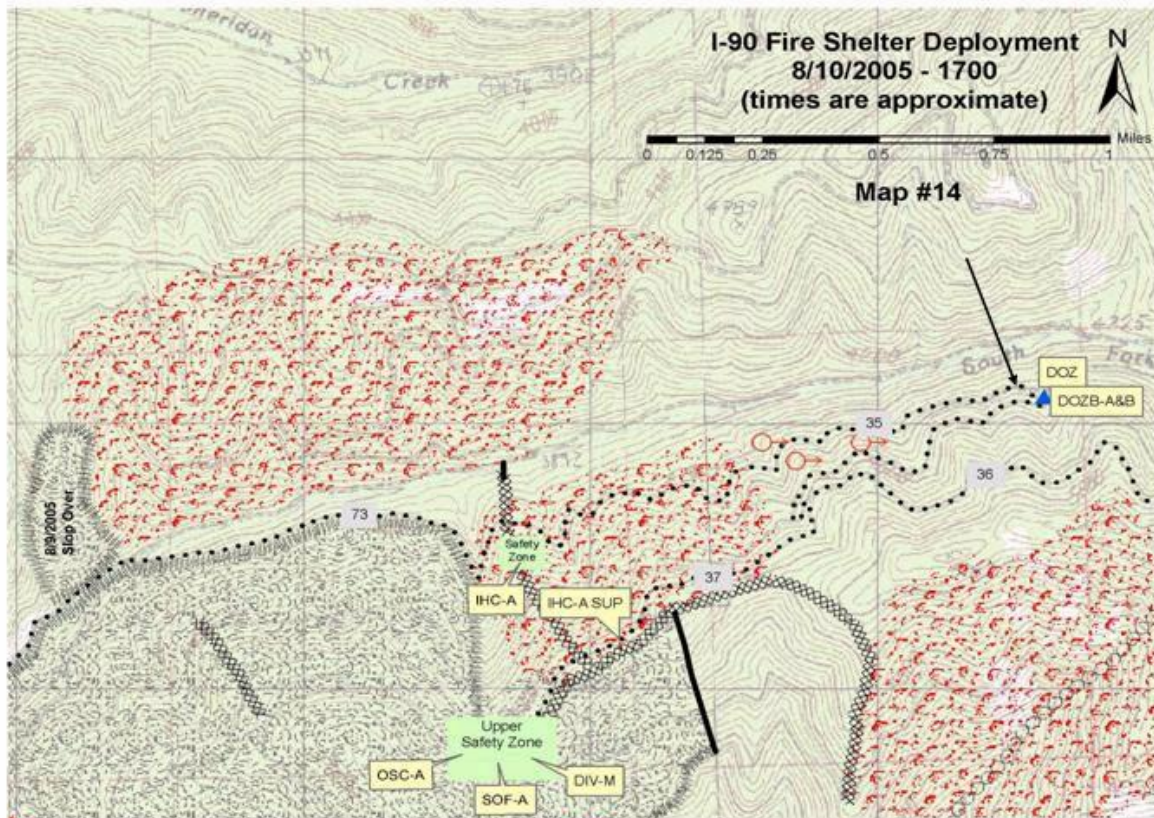
(Maps 13 and 14)

At 1630 all the resources from the slop-over are accounted for by Task Force Leader-A and Branch at Drop Point-22. Division-M further discusses with Dozer Boss-A the appropriateness of their alternate safety zone to ensure it is adequate. A few minutes later the Dozer is working to further improve the safety zone, including removing the fuel from the area between the roads, west of the switch back. (See safety zone detail.)

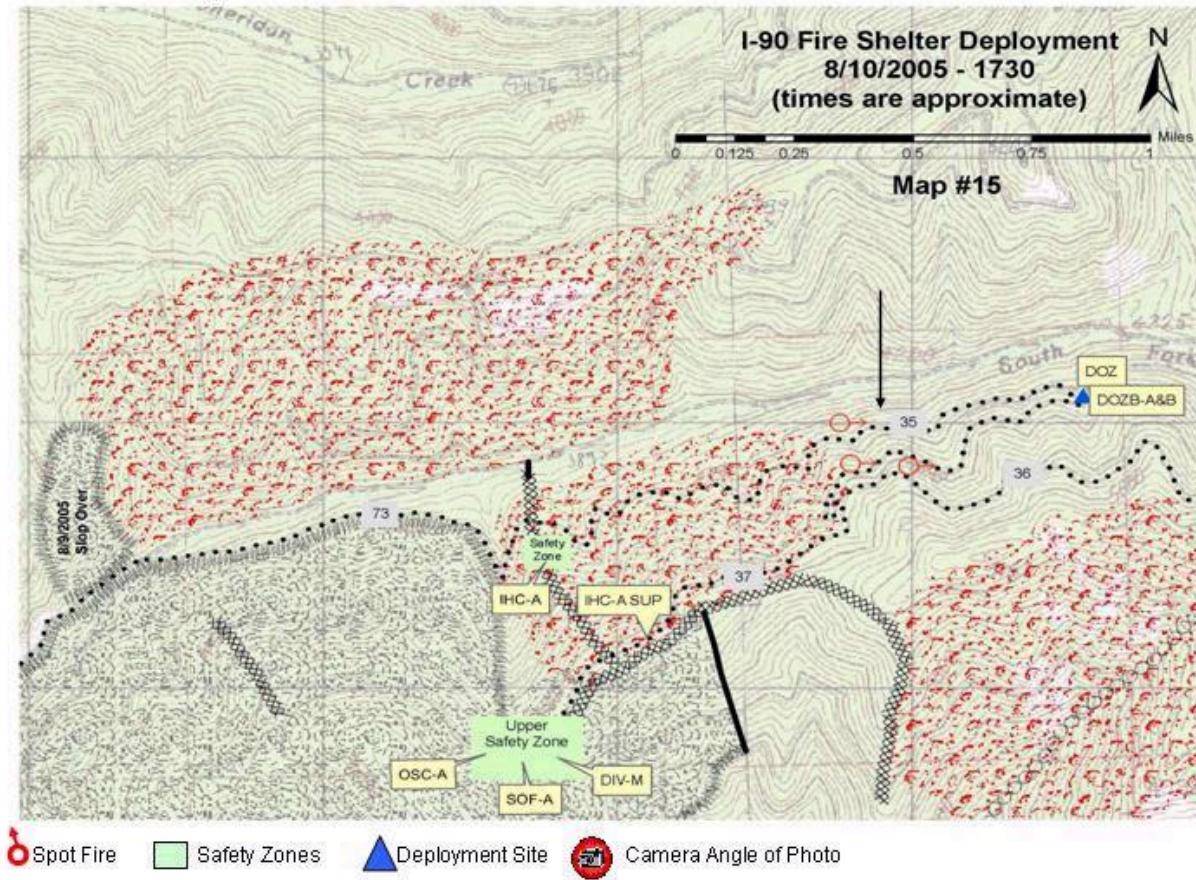
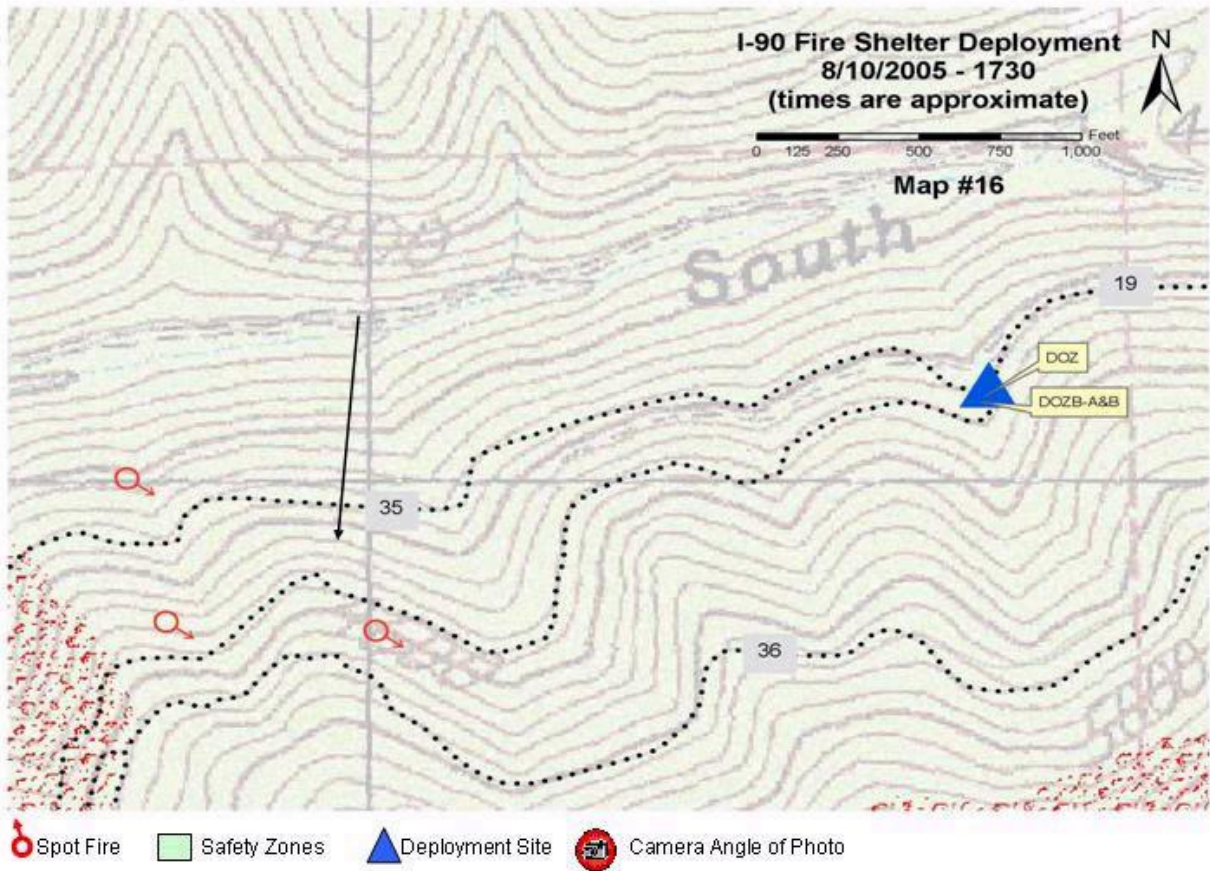
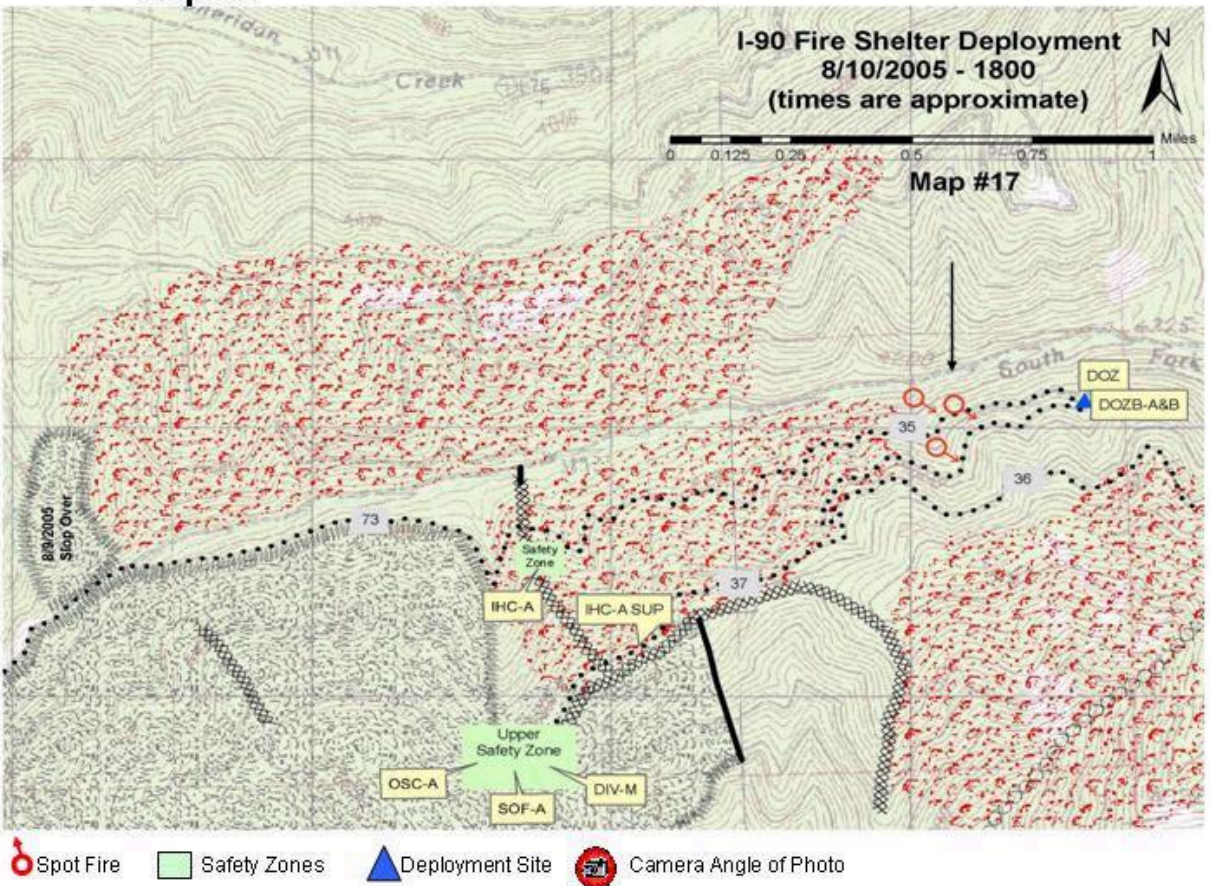
(Maps 15, 16, and 17 – Photos 6 and 7).

By 1730 discussions at the Operations Section Chief/ Branch level consider establishing an anchor at the heel of the slopover and going to work, but they determine conditions are too dangerous. The slopover across the drainage has a full head of steam, proceeding east, along the ridge (Photos 6 and 7).

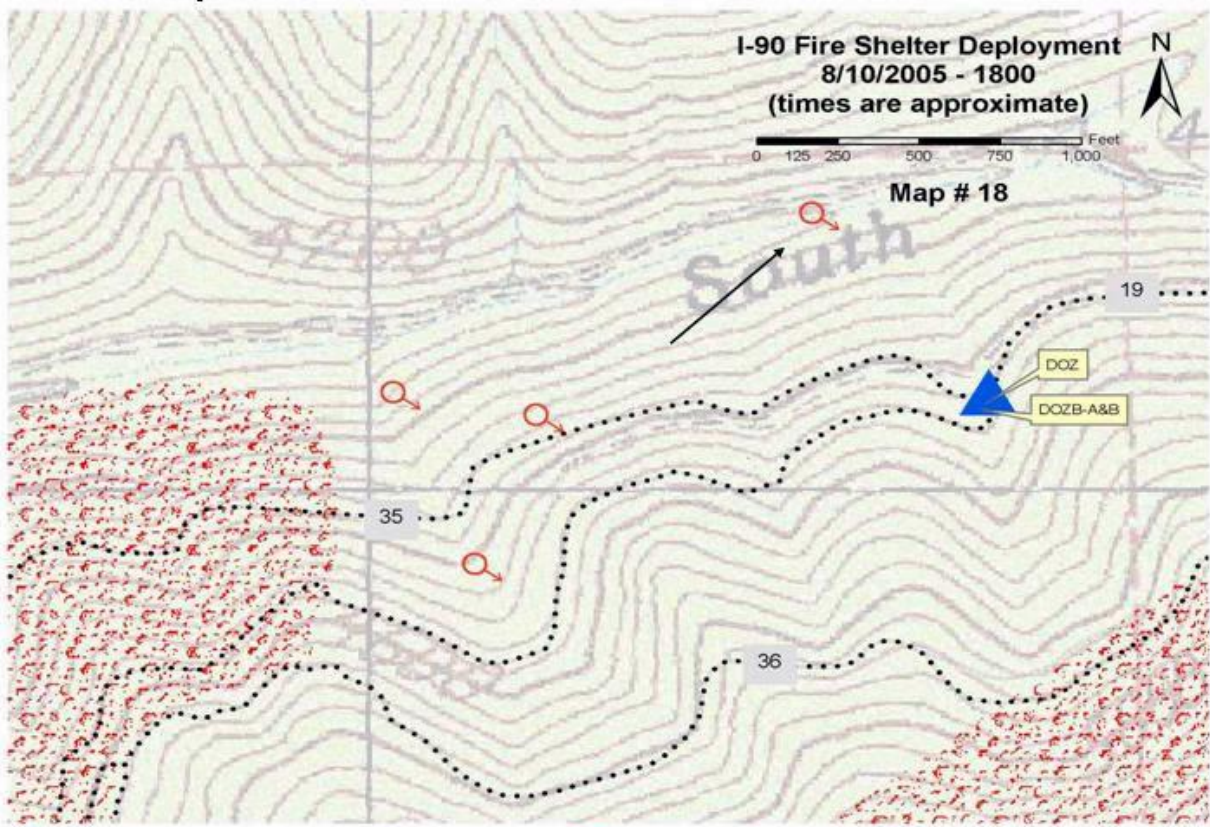
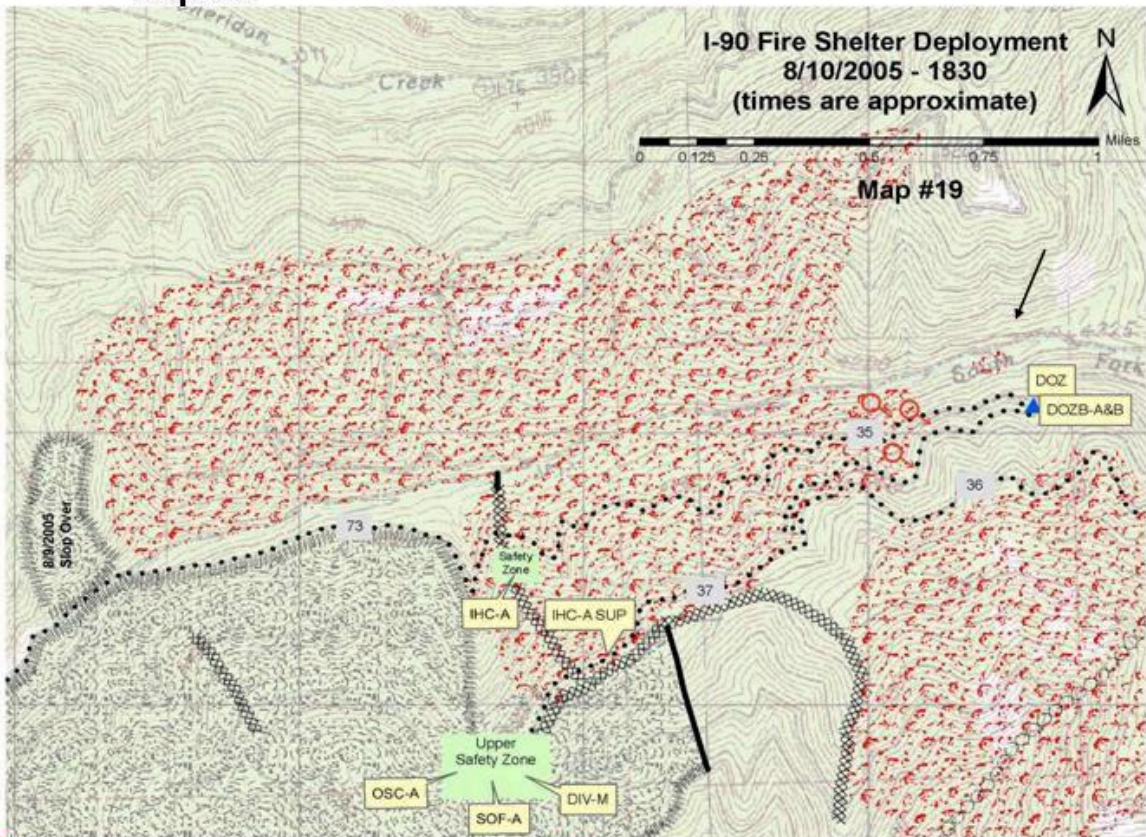
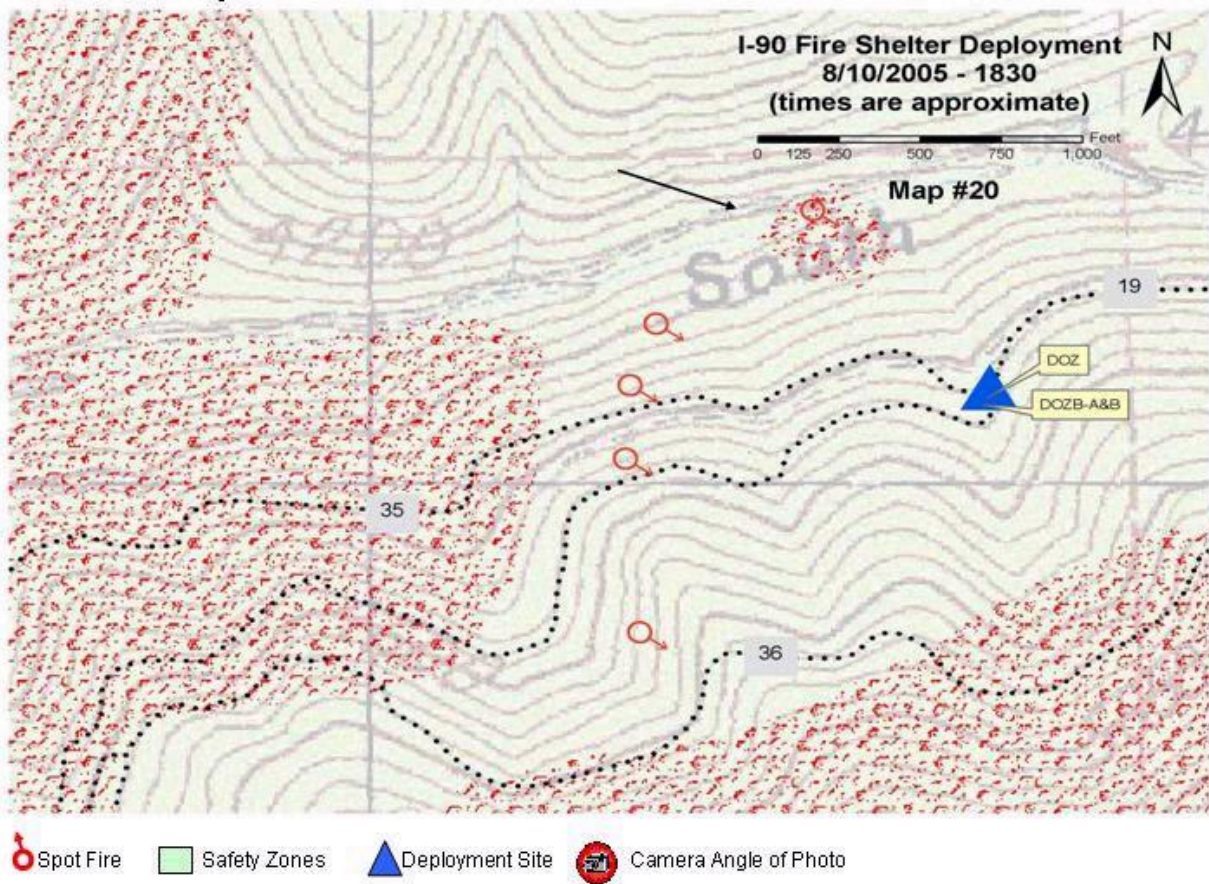
(Maps 18, 19, and 20)

By 1800, a spot appears in the drainage directly below the alternate safety zone.
