Accident Investigation Report

FIRE SHELTER DEPLOYMENT
I-90 COMPLEX, LOLO NATIONAL FOREST
NORTHERN ROCKIES
MISSOULA, MONTANA

August 10, 2005

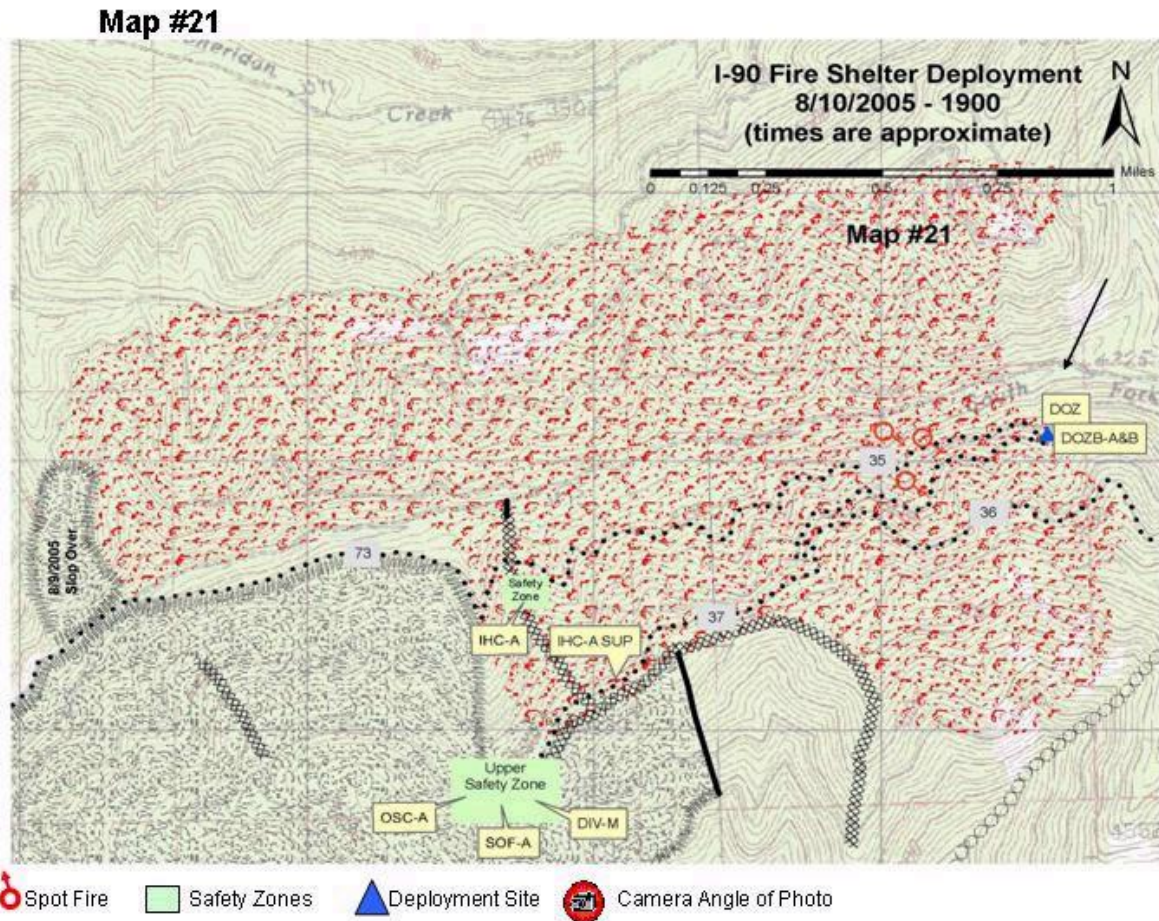
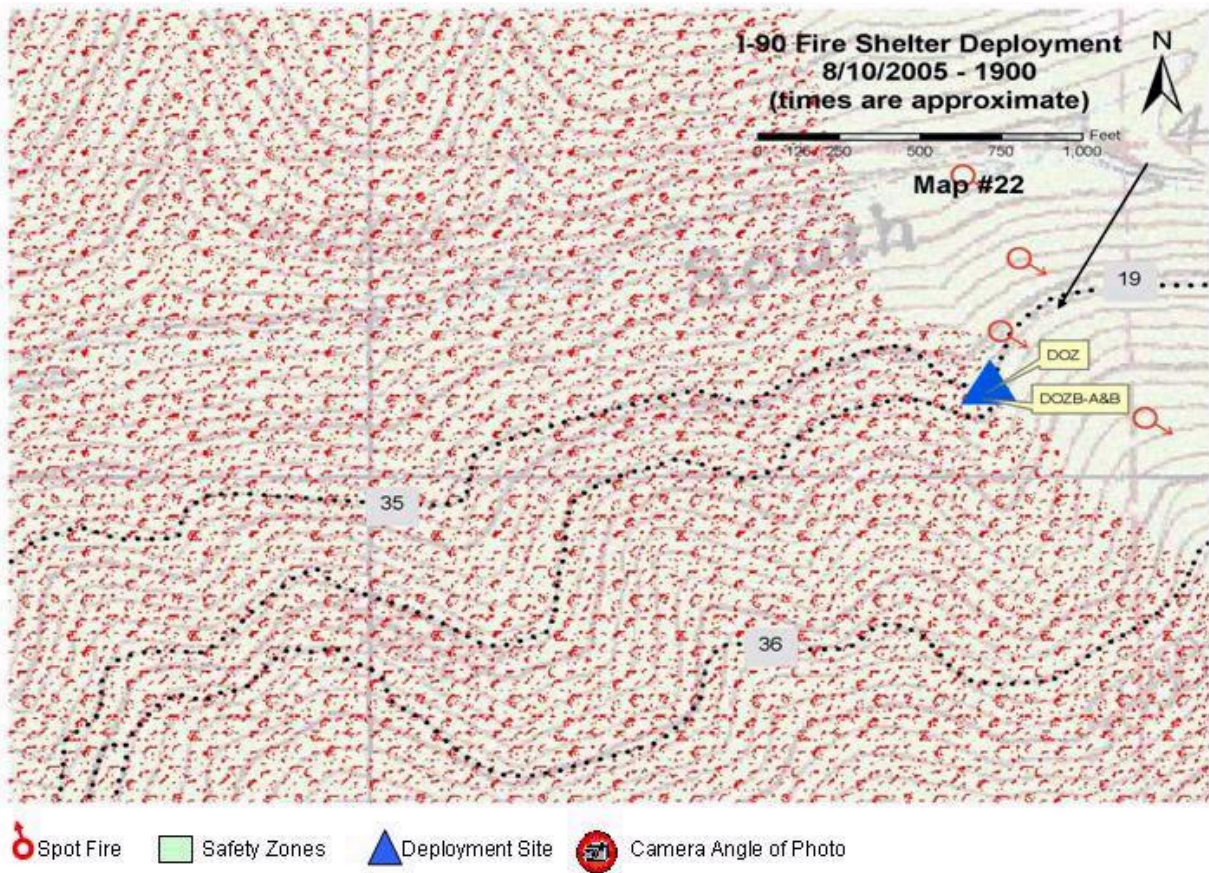
(Maps 21 and 22)

The three are in the alternate safety zone for over 2 hours. Fire behavior is active to be sure, but has not reached peak intensity. At 1850 they are crouched in front of the blade. Close to 1900 the fire reaches the alternate safety zone. It has also moved up-canyon to that same point on the north side. Conditions at the alternate safety zone get quite exciting, with flame reaching from the west side all the way over the dozer, 20 feet above their heads (~110 to 150 feet horizontal flame length). Small trees snap off in the canyon below and a rain of embers pelts them from all angles. The embers are becoming unbearable when the radiant heat from the fire above the cut bank makes it obvious it is time to shelter-up, and Dozer Boss-A gives the order.
